# Deterioration and Preservation of City Wall in Nanjing

Energy Procedia 132 (2017) 945–950

11th Nordic Symposium on Building Physics, NSB2017, 11-14 June 2017, Trondheim, Norway

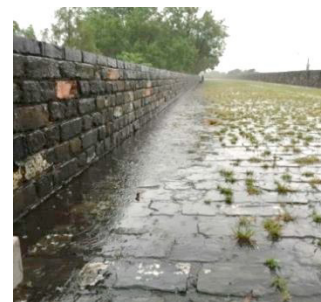
Fig. 2 Types of wall structures

Nanjing City Wall was constructed during a 21-year period during the Ming Dynasty, from 1368 to 1644 (Fig. 1). Although the City Wall is currently separated into five sections, more than two-thirds of the originally constructed wall, i.e., 25,091 km, still remains. The City Wall is made of bricks and stones. The bricks are of different sizes and materials (ingredients) because they were produced at various places throughout China. Plaster and soil were used as masonry joints. The wall structure is roughly categorized into two types. One is a self-bearing type, which is not in contact with any large masses of soil on the rear face, and where both sides of the wall are made of bricks. The other one is a covering type, whose rear side is large mass of soil, where the wall is constructed such that it surrounds the soil mass (Fig. 2). The inside of a self-bearing type wall is either soil or only bricks.
